Detector Operations

August 15, 2002

CDF Weekly Meeting

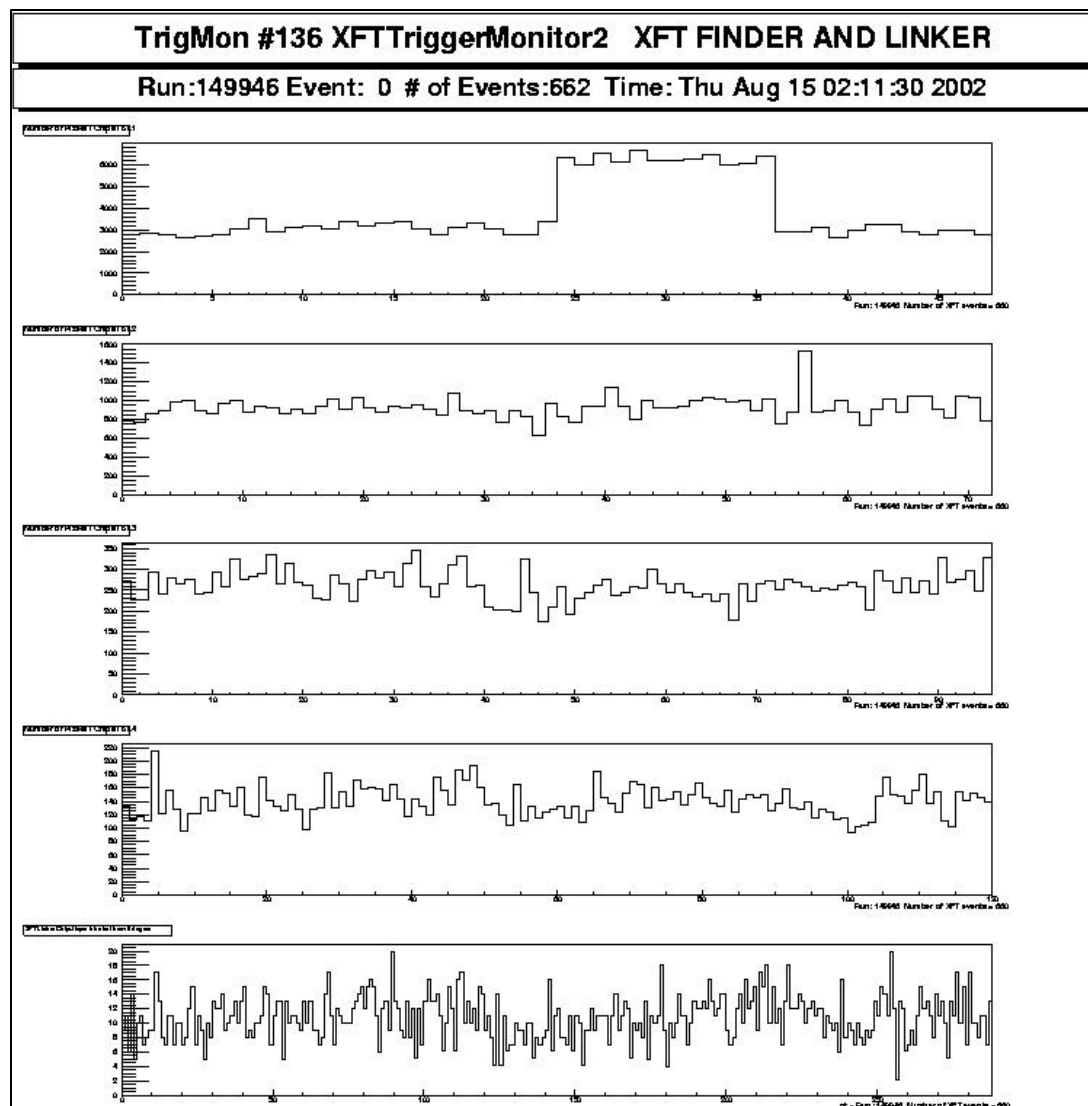
XFT Performance

- On Wednesday morning, the XFT people loaded constants to mask on these 192 wires in the trigger.
- Trigger performance looks to be relatively unaffected.
- Initial conclusion seems to be that we can take quality data in this configuration.

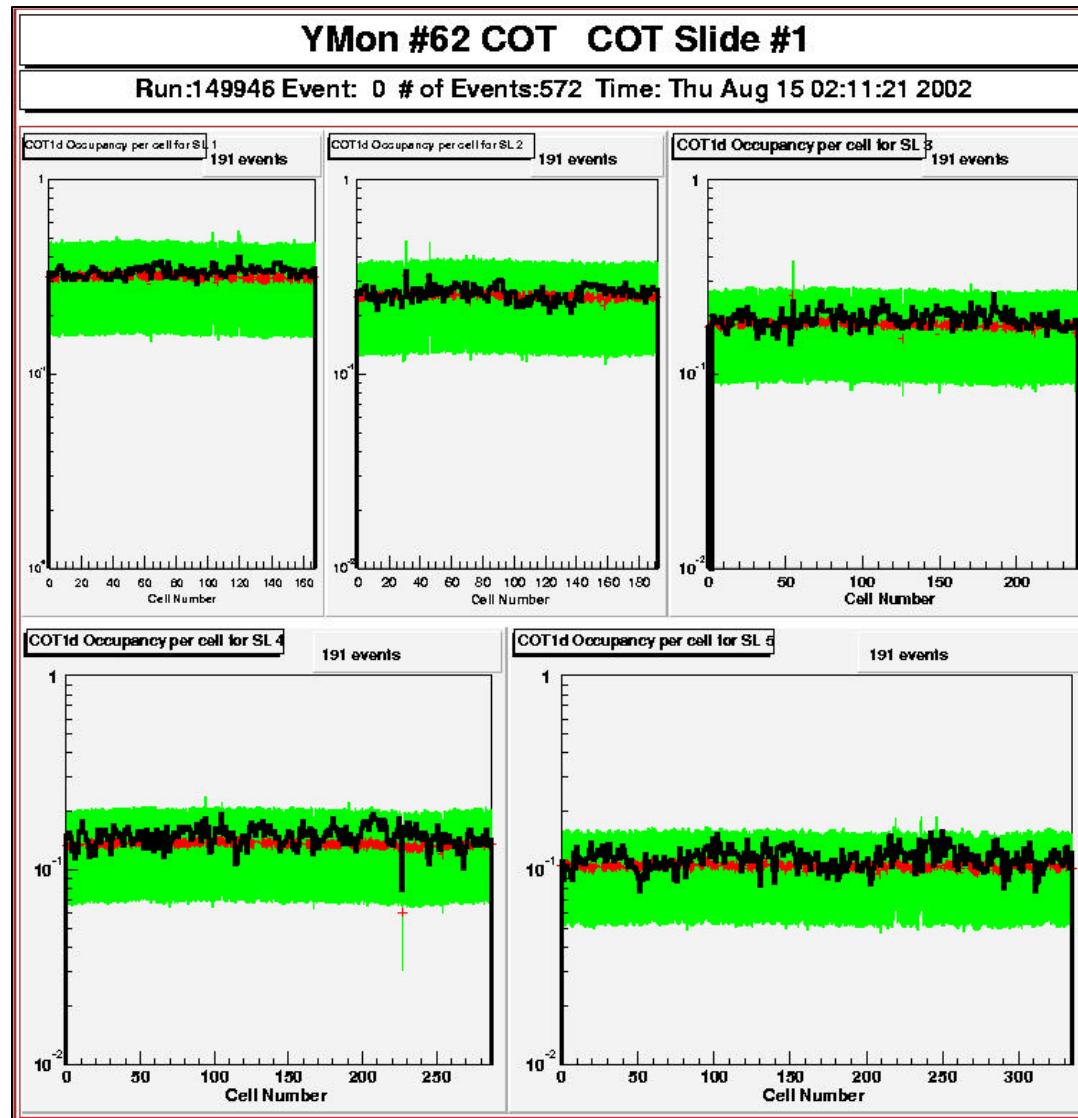
Present COT Status

- On Tuesday, COT experts were able to construct a stable running configuration with Sense Wires 4-7 disabled for all cells in quadrant C (48 cells x 4 wires).
- This granularity is primarily imposed by a limitation of the HV daughter-boards ($dV < 125V$ for neighboring channels).
